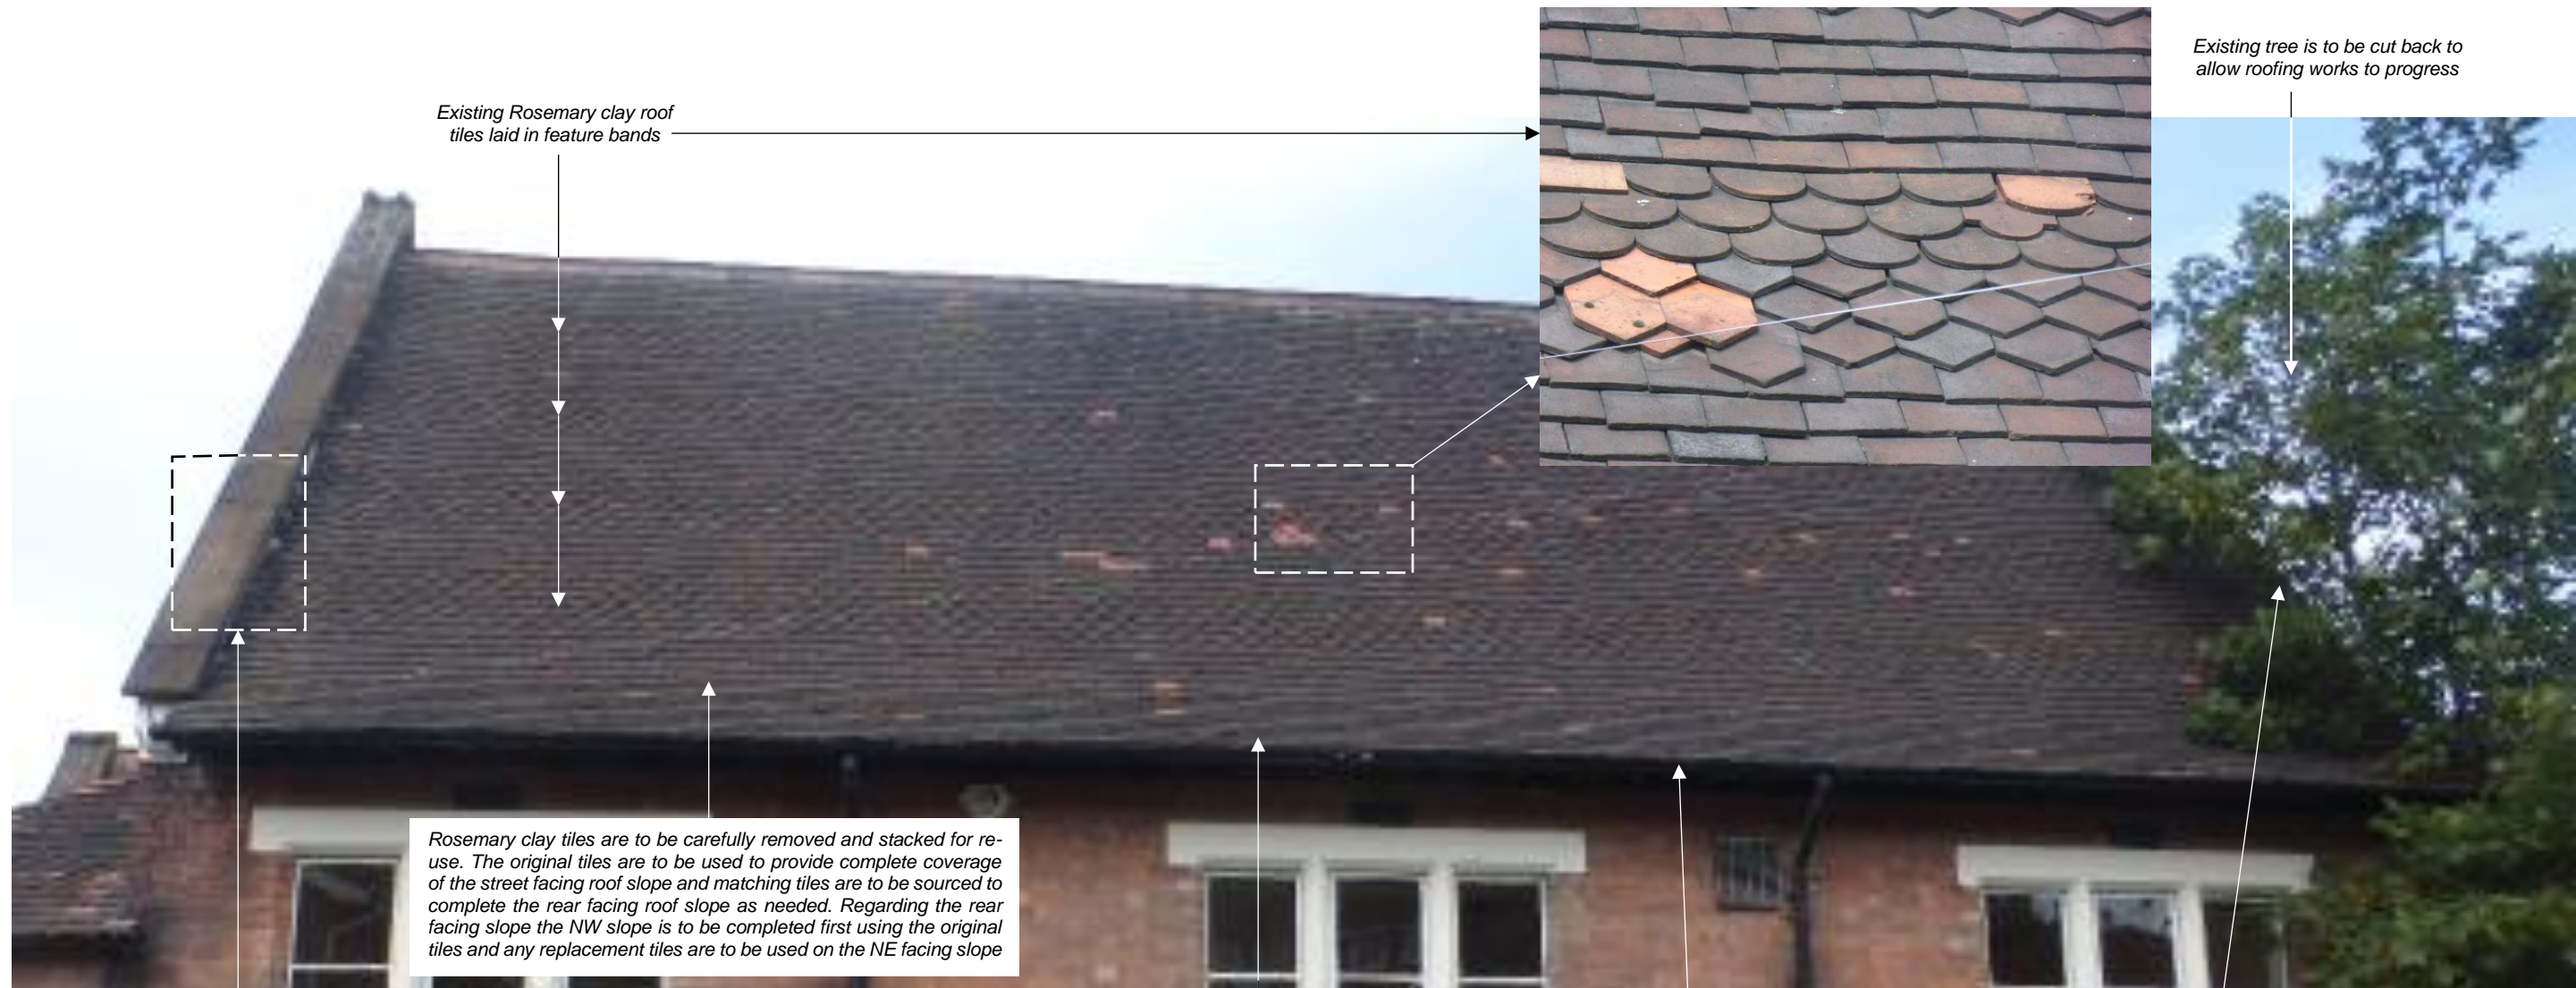
Existing Rosemary clay roof tiles laid in feature bands

Existing tree is to be cut back to allow roofing works to progress

Rosemary clay tiles are to be carefully removed and stacked for re-use. The original tiles are to be used to provide complete coverage of the street facing roof slope and matching tiles are to be sourced to complete the rear facing roof slope as needed. Regarding the rear facing slope the NW slope is to be completed first using the original tiles and any replacement tiles are to be used on the NE facing slope

Gutters are to be cleaned out and all support bracket fixings are to be checked and repaired as necessary
